HAMPTON 235/025
NH 1A over HAMPTON RIVER

Owner: NHDOT
Inspection Team: C
Bridge Maintenance Crew: 15

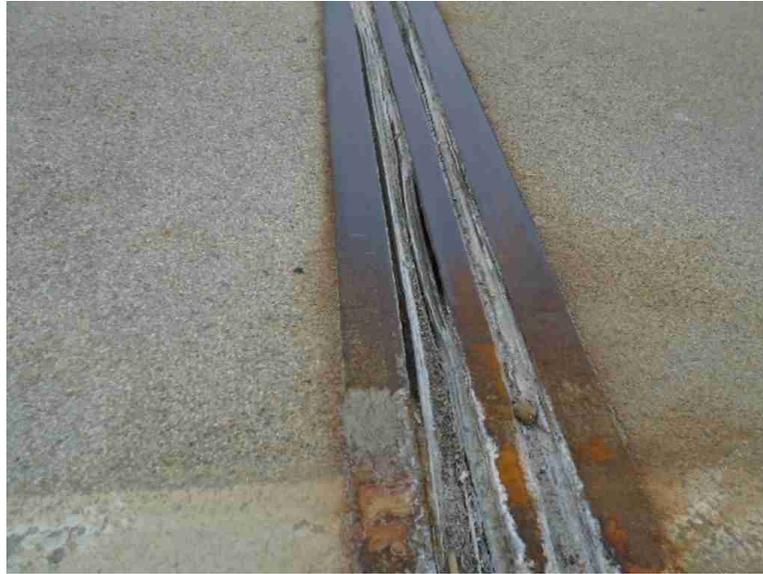
C612 02

GLAND PULLED OUT OF
POSITION. TYPICAL OF ALL.
(RL)

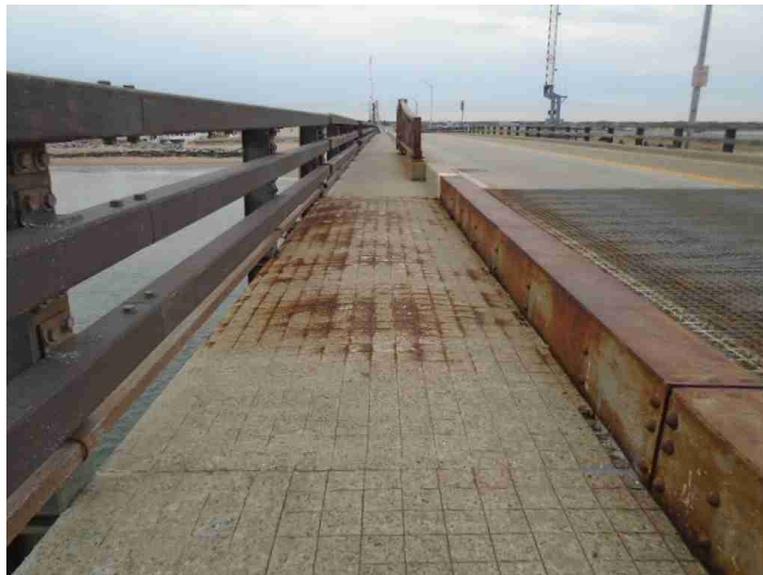
C612 03

WALKWAY AT GRID IS
HEAVILY RUSTED, RAISED
AND CRACKED. (RL)

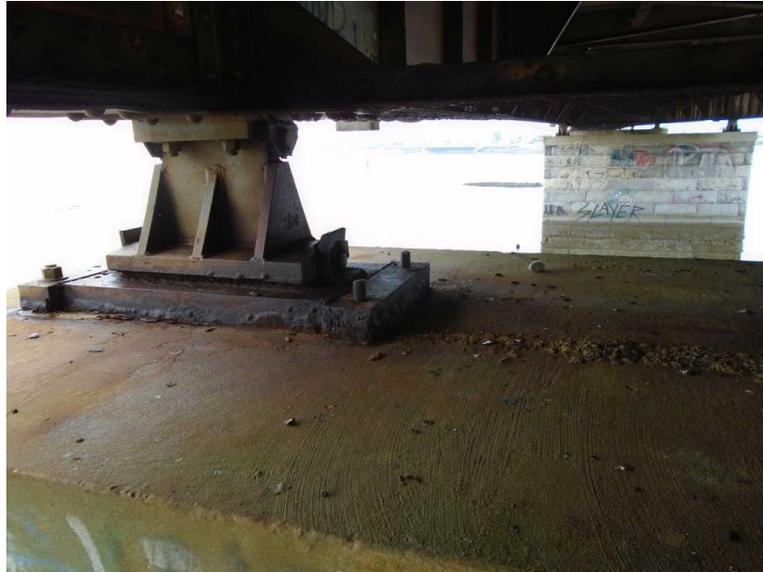
C606 59

PIER #1 NUTS MISSING AT BEARING.

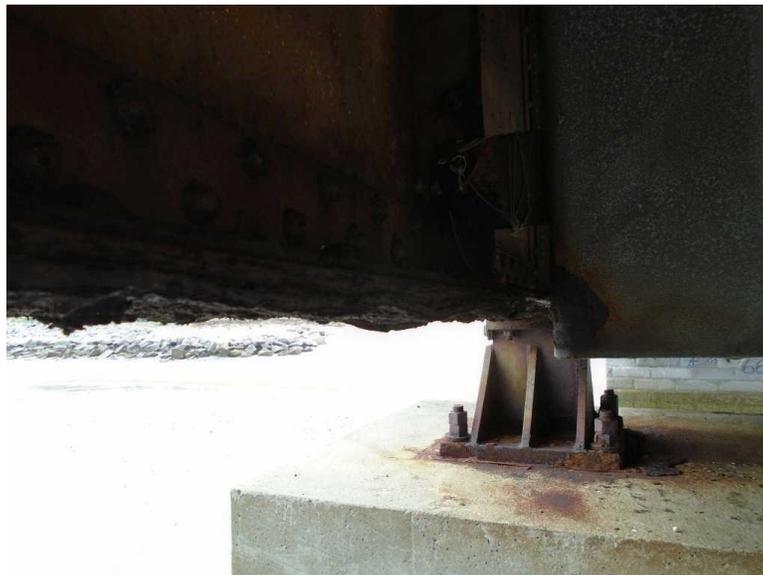
C606 60

PACK RUST AT GIRDER.

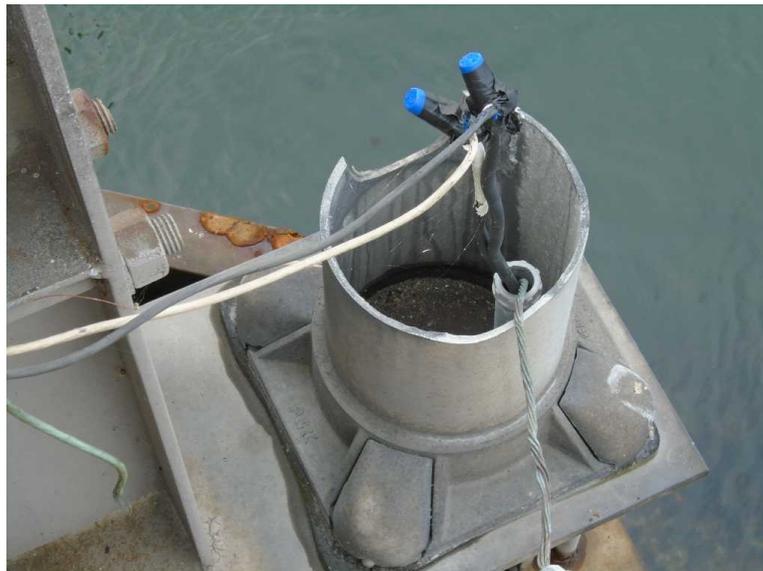
C606 61

LIGHT POLE MISSING.

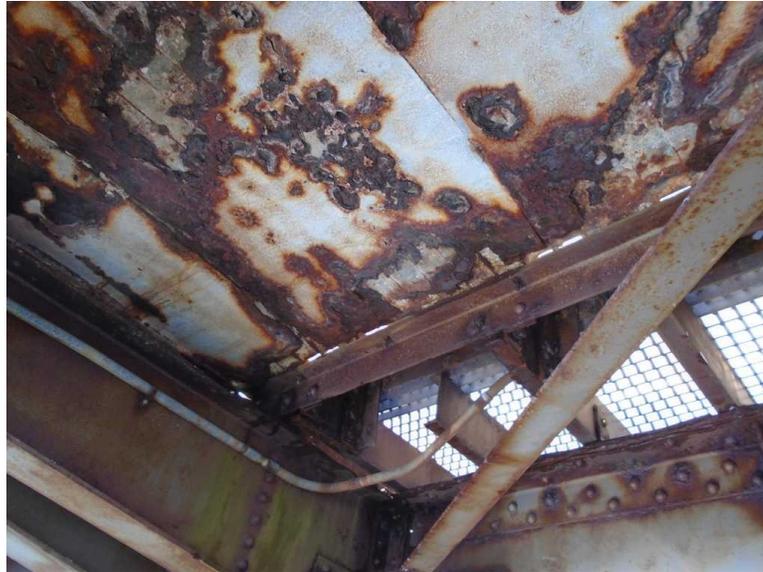
C606 62

PANELS AT UNDER
SIDEWALK HOLED.

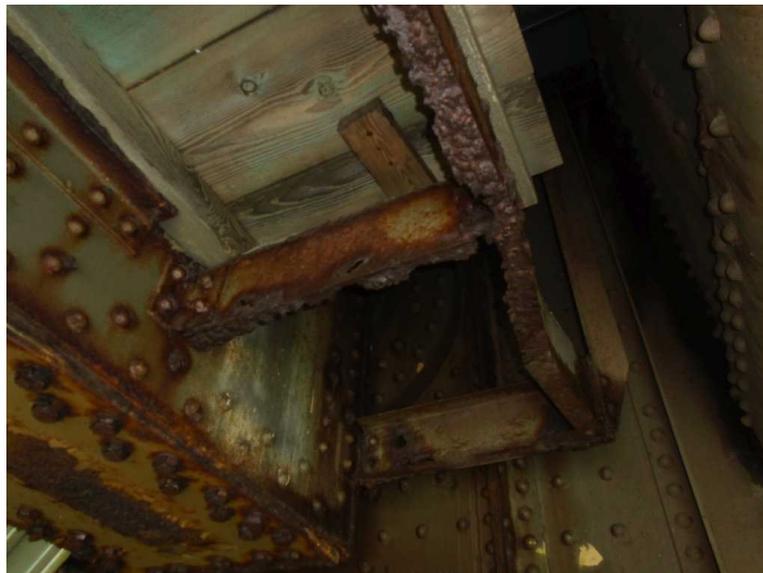
C606 63

PLATFORM IS RUSTED AND
HOLED.

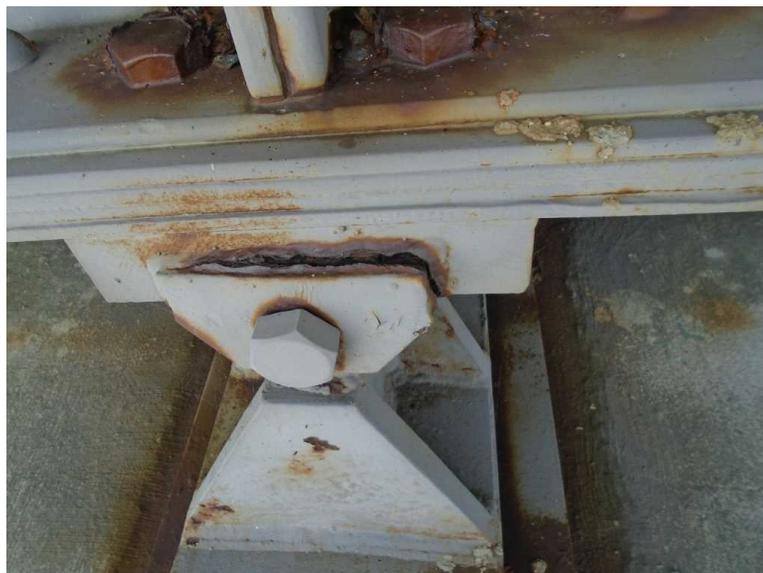
C606 64

CRACKED WELD AT
BEARING AT PIER #9.

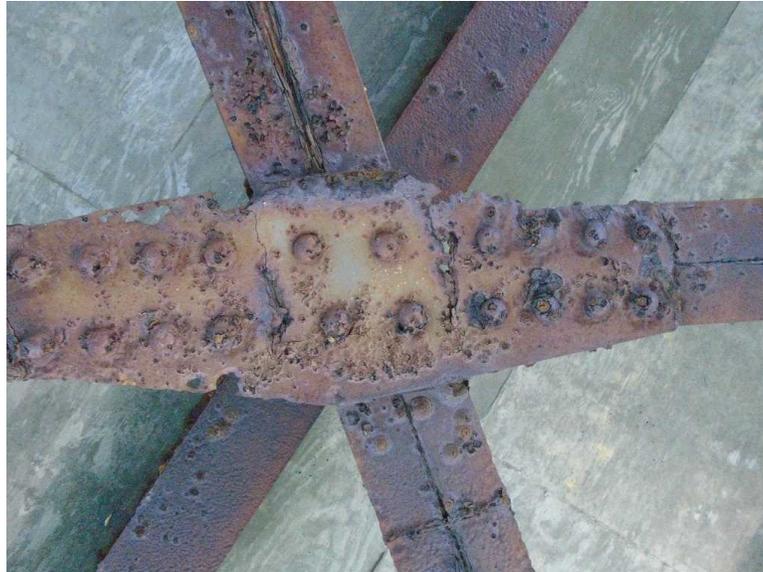
C606 65

CROSS BRACING HOLED AT
SPAN #10.
